# Mobile Intel® Pentium® 4 Processor-M

## Specification Update

*May 2005*

Document Number: 250721-029

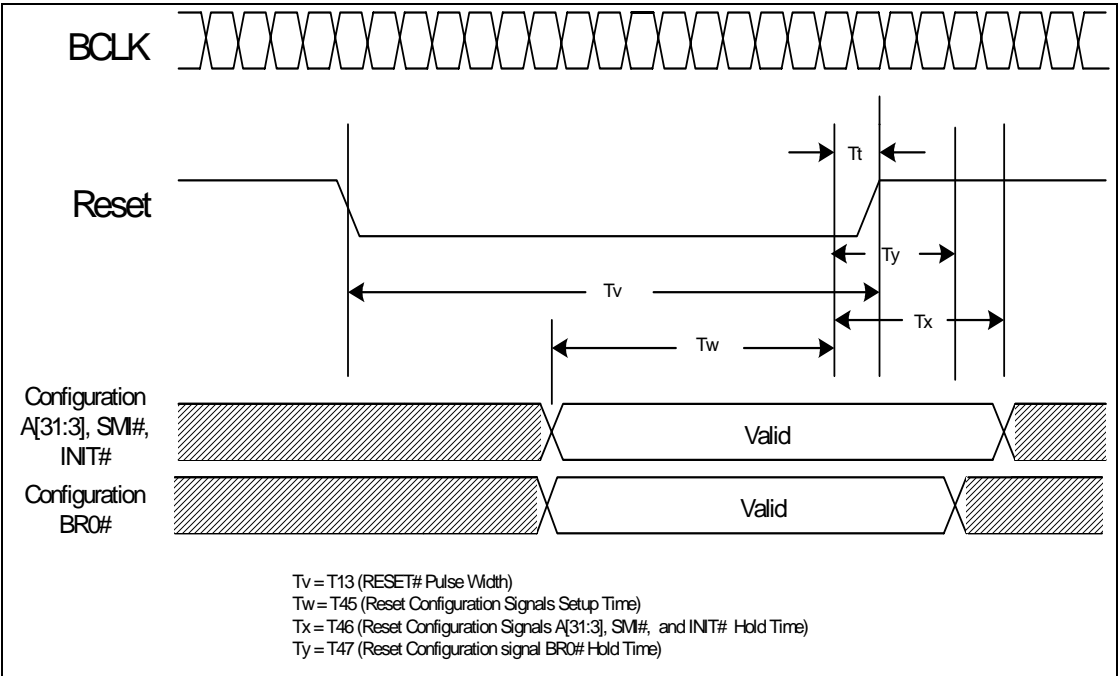
Figure 13. System Bus Reset and Configuration Timings

The BR0# maximum hold time has changed to 2 BCLKs. This change will be shown in the “System Bus AC Specifications (Reset Conditions)” table and “System Bus Reset and Configuration Timings” figure of the *Mobile Intel® Pentium® 4 Processor - M Datasheet*. This change will be incorporated in the next revision of the datasheet.

The following figure will be modified to reflect this change:
